**Flood Control Project Maintenance
Levee Inspections****LMA District Cover Sheet
Spring 2015 Levee Inspection Results****Sutter Maintenance Yard East-West Interceptor**

Spring 2015 Levee Inspection Results

Sutter Maintenance Yard East-West Interceptor

Waterway			Bank	Unit Miles
Unit No. 01 West Levee			Right	1.75
	Spring (March - May)	Summer (June - August)	(September - November) Fall	Winter (December - February)
Unit Maintenance Rating (Fall Only)				
Date of Inspection	04/14/2015 - 04/14/2015			
DWR Inspector	Bob Duffey			
Accompanied By	Steve Beckley Sutter Maintenance Yard

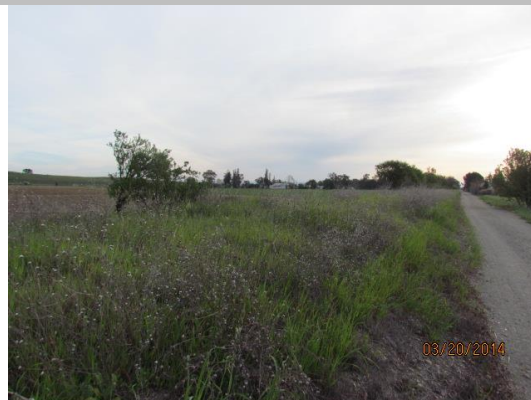
Photo 1 of 1 : SP_2015_ST0020_213_7_20150310_00004.jpg

LM Start	0.00	Rating **	M	Issue No.	7
LM End	0.32	Issue Type +	Ma	Location *	WS
Category	Earthen Levee			GPS Latitude/Longitude	
				Start	End
Item	Vegetation			39.171577 °	39.171481 °
				-121.760019 °	-121.754826 °
DWR ID	DWR_NA0020_01_s _ 2012_7				
Action/Comments					
Remove the wild growth other than native grasses from the levee slopes.

View of the vegetation along the w/s toe.

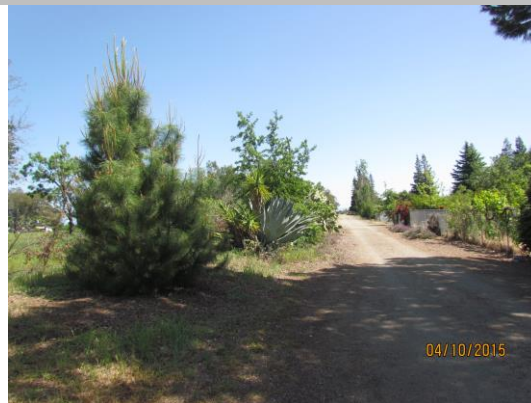
Photo 1 of 1 : SP_2015_ST0020_213_2_20150420_00006.jpg

LM Start	0.23	Rating **	M	Issue No.	2
LM End	0.25	Issue Type +	En	Location *	CR
Category	Earthen Levee			GPS Latitude/Longitude	
				Start	End
Item	Vegetation			39.171418 °	39.171408 °
				-121.755963 °	-121.755578 °
DWR ID	DWR_NA0020_01_s _ 2012_2				
Action/Comments					
Landscaping Inspector Comments: Remove the cactus and pine trees from the waterside berm.

View of the cactus and pine trees along the waterside berm.

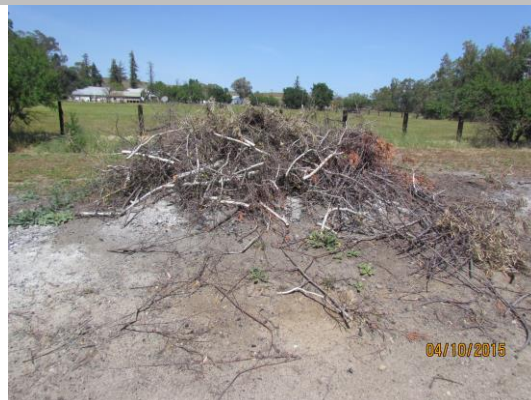
Photo 1 of 1 : SP_2015_ST0020_213_23_20150420_00008.jpg

LM Start	0.36	Rating **	M	Issue No.	23
LM End	0.36	Issue Type +	En	Location *	CR
Category	Earthen Levee			GPS Latitude/Longitude	
				Start	End
Item	Encroachments			39.171450 °	39.171450 °
				-121.754058 °	-121.754058 °
DWR ID	DWR_NA0020_01_f_2013_23				
Action/Comments					
Prunings					
Inspector Comments: Remove the prunings from the waterside berm.

Remove the prunings from the waterside berm.

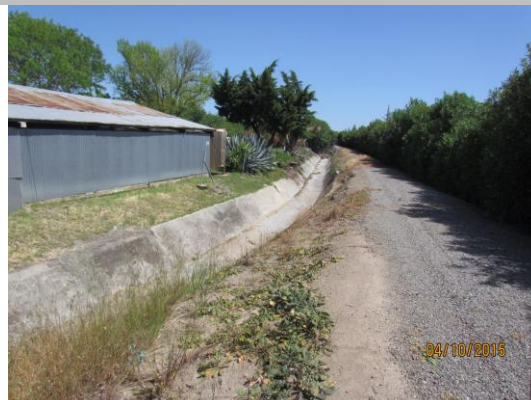
Photo 1 of 1 : SP_2015_ST0020_213_4_20150420_00009.jpg

LM Start	0.62	Rating **	U	Issue No.	4
LM End	0.65	Issue Type +	Ma	Location *	WS
Category	Earthen Levee			GPS Latitude/Longitude	
				Start	End
Item	Erosion / Bank Caving			39.171292 °	39.171232 °
				-121.748868 °	-121.748175 °
DWR ID	DWR_NA0020_01_s_2012_4				
Action/Comments					
Schedule repair of erosion site prior to the next inspection. Inspector Comments: Repair the erosion along the concrete ditch before winter.

Repair the erosion along the concrete ditch before winter.

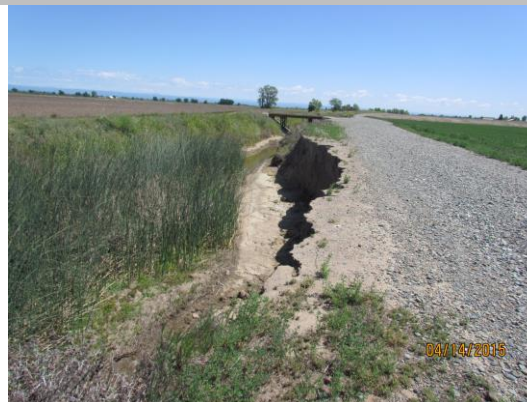
Photo 1 of 1 : SP_2015_ST0020_213_6_20150420_00010.jpg

LM Start	1.67	Rating **	U	Issue No.	6
LM End	1.67	Issue Type +	Ma	Location *	WS
Category	Rivers, Channels & Designated Floodways			GPS Latitude/Longitude	
				Start	End
Item	Erosion / Bank Caving			39.171128 °	39.171128 °
				-121.729235 °	-121.729235 °
DWR ID	DWR_NA0020_01_s _ 2012_6				
Action/Comments					
Inspector Comments: Sutter Yard needs to repair the erosion before winter.

Repair the erosion along the waterside slope.

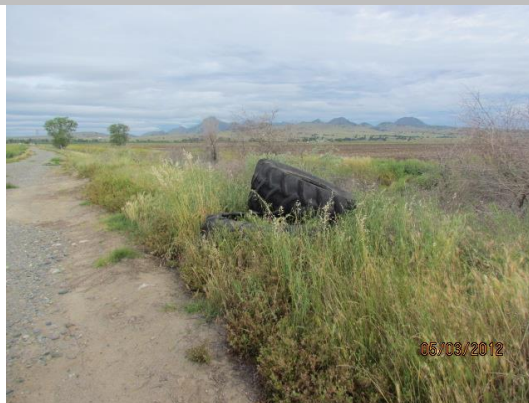
Photo 1 of 1 : SP_2015_ST0020_214_12_20150310_00009.jpg

LM Start	0.25	Rating **	M	Issue No.	12
LM End	0.25	Issue Type +	En	Location *	WS
Category	Earthen Levee			GPS Latitude/Longitude	
				Start	End
Item	Encroachments			39.171107 °	39.171107 °
				-121.722069 °	-121.722069 °
DWR ID	DWR_NA0020_02_s _ 2012_12				
Action/Comments					
Garbage					
Inspector Comments: Tires

View of the tires along the W/S toe.

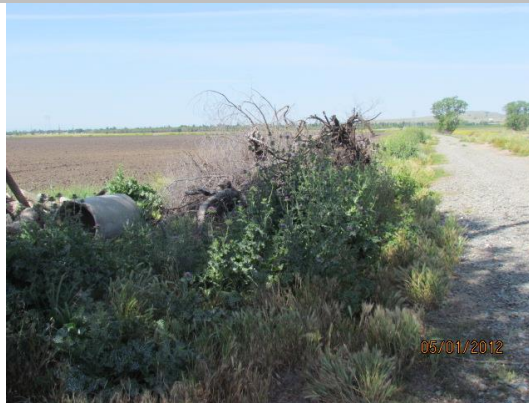
Photo 1 of 1 : SP_2015_ST0020_214_9_20150310_00007.jpg

LM Start	0.26	Rating **	M	Issue No.	9
LM End	0.26	Issue Type +	En	Location *	LS
Category	Earthen Levee			GPS Latitude/Longitude	
				Start	End
Item	Encroachments			39.171101 °	39.171101 °
				-121.721856 °	-121.721856 °
DWR ID	DWR_NA0020_02_s _ 2012_9				
Action/Comments					
Debris

View of the debris along the L/S toe.

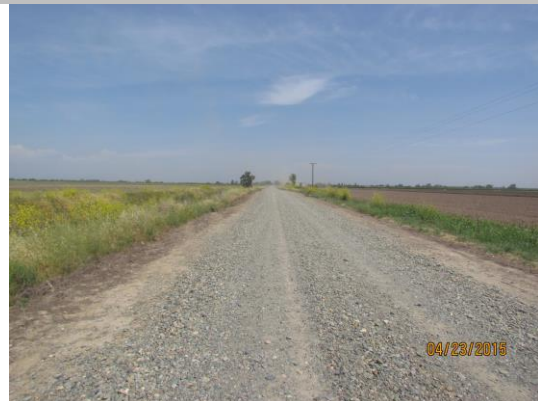
Photo 1 of 1 : SP_2015_ST0020_214_2_20150428_00016.jpg

LM Start	0.55	Rating **	M	Issue No.	2
LM End	2.72	Issue Type +	Ma	Location *	WS
Category	Earthen Levee			GPS Latitude/Longitude	
				Start	End
Item	Vegetation			39.171002 °	39.170507 °
				-121.716293 °	-121.676212 °
DWR ID	DWR_NA0020_02_s_2012_2				
Action/Comments					
Remove the wild growth other than native grasses from the levee slopes.					
Inspector Comments: Remove the vegetation from both slopes.

View of the vegetation on both slopes.

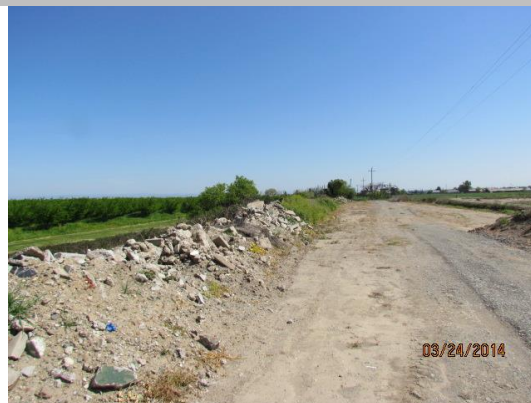
Photo 1 of 1 : SP_2015_ST0020_214_3_20150310_00003.jpg

LM Start	1.43	Rating **	M	Issue No.	3
LM End	1.55	Issue Type +	Ma	Location *	LS
Category	Earthen Levee			GPS Latitude/Longitude	
				Start	End
Item	Encroachments			39.170782 °	39.170817 °
				-121.700167 °	-121.698203 °
DWR ID	DWR_NA0020_02_s_2012_3				
Action/Comments					
Debris

View of the piles of broken concrete next to the levee.

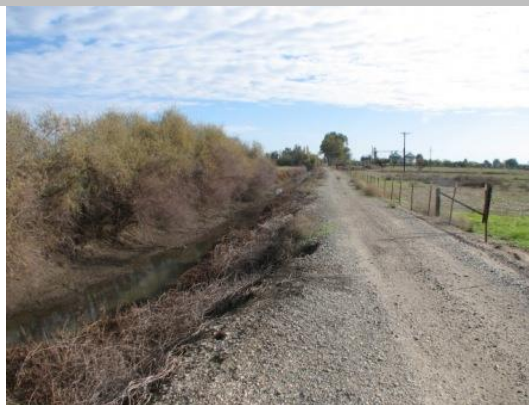
Photo 1 of 1 : SP_2015_ST0020_214_4_20150310_00004.jpg

Action/Comments					
Note and monitor erosion site.

View of the erosion along the waterside slope.

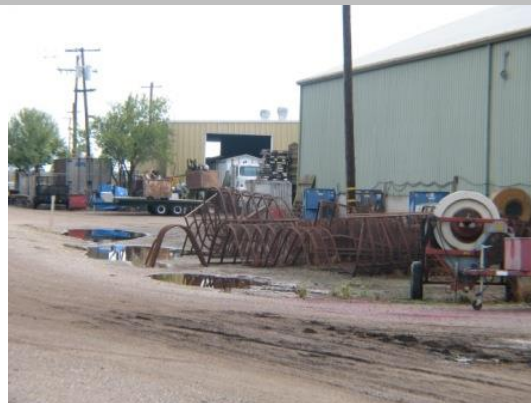
Photo 1 of 1 : SP_2015_ST0020_214_5_20150310_00005.jpg

LM Start	1.92	Rating **	M	Issue No.	5
LM End	2.04	Issue Type +	Ma	Location *	LS
Category	Earthen Levee			GPS Latitude/Longitude	
				Start	End
Item	Encroachments			39.171104 °	39.171104 °
				-121.718880 °	-121.718876 °
DWR ID	DWR_NA0020_02_s _ 2012_5				
Action/Comments					
Equipment

View of the equipment and buildings next to the landside berm.

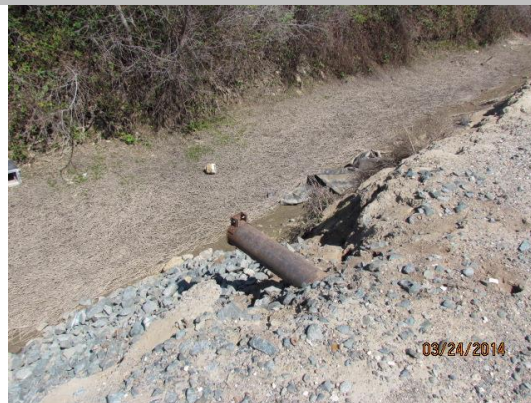
Photo 1 of 1 : SP_2015_ST0020_214_26_20150310_00013.jpg

LM Start	1.93	Rating **	U	Issue No.	26
LM End	1.93	Issue Type +	En	Location *	CR
Category	Earthen Levee			GPS Latitude/Longitude	
				Start	End
Item	Encroachments			39.170743 °	39.170743 °
				-121.690644 °	-121.690644 °
DWR ID	DWR_ST0020_02_s _ 2014_26				
Action/Comments					
Pipe

View of the unauthorized pipe going through the crown of the levee.

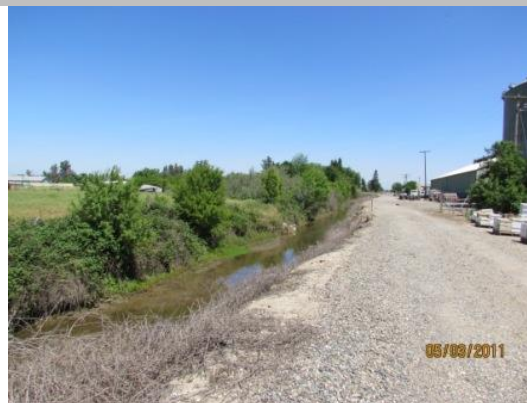
Photo 1 of 1 : SP_2015_ST0020_214_6_20150310_00006.jpg

LM Start	1.95	Rating **	M	Issue No.	6
LM End	1.98	Issue Type +	Ma	Location *	LS
Category	Earthen Levee			GPS Latitude/Longitude	
				Start	End
Item	Erosion / Bank Caving			39.170775 °	39.170775 °
				-121.691252 °	-121.691255 °
DWR ID	DWR_NA0020_02_s_2012_6				
Action/Comments					
Note and monitor erosion site.

View of the erosion along the W/S slope.

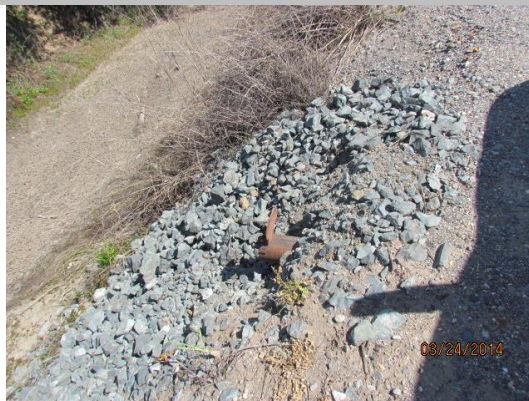
Photo 1 of 1 : SP_2015_ST0020_214_27_20150310_00014.jpg

LM Start	1.97	Rating **	U	Issue No.	27
LM End	1.97	Issue Type +	En	Location *	CR
Category	Earthen Levee			GPS Latitude/Longitude	
				Start	End
Item	Encroachments			39.170777 °	39.170777 °
				-121.689820 °	-121.689820 °
DWR ID	DWR_ST0020_02_s_2014_27				
Action/Comments					
Pipe

View of the unauthorized pipe going through the crown of the levee.

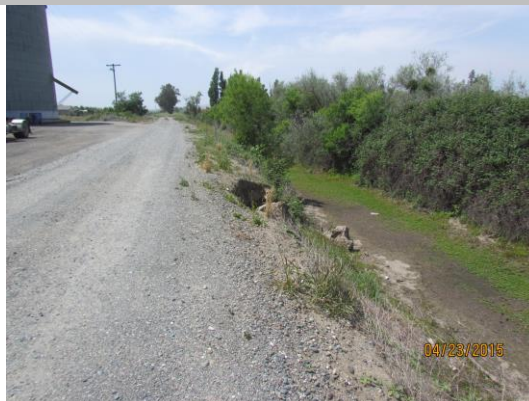
Photo 1 of 1 : SP_2015_ST0020_214_17_20150428_00018.jpg

LM Start	2.02	Rating **	M	Issue No.	17
LM End	2.02	Issue Type +	Ma	Location *	WS
Category	Earthen Levee			GPS Latitude/Longitude	
				Start	End
Item	Erosion / Bank Caving			39.170756 °	39.170756 °
				-121.689841 °	-121.689841 °
DWR ID	DWR_NA0020_02_s_2013_17				
Action/Comments					
Note and monitor erosion site.					
Inspector Comments: Repair the erosion along the waterside slope.

View of the erosion along the waterside slope.

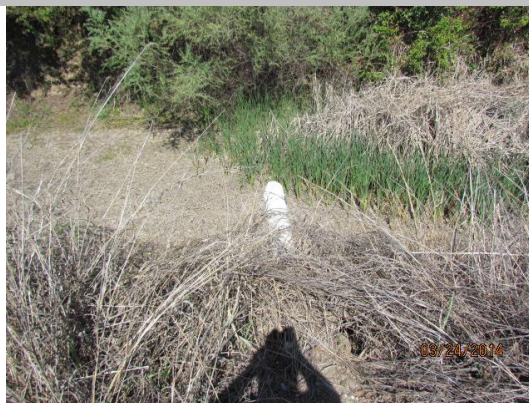
Photo 1 of 1 : SP_2015_ST0020_214_18_20150310_00011.jpg

LM Start	2.02	Rating **	U	Issue No.	18
LM End	2.02	Issue Type +	En	Location *	WS
Category	Earthen Levee			GPS Latitude/Longitude	
				Start	End
Item	Encroachments			39.170756 °	39.170756 °
				121.689840 °	121.689840 °
DWR ID	DWR_NA0020_02_s_2013_18				
Action/Comments					
Pipe					
Inspector Comments: View of an unauthorized pipe going through the crown of the levee.

View of the unauthorized pipe going through the crown of the levee.

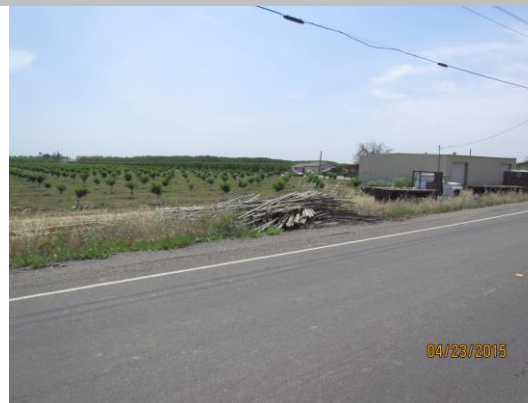
Photo 1 of 1 : SP_2015_ST0020_214_10_20150428_00015.jpg

Action/Comments					
Material Inspector Comments: Remove the lumber, garbage and equipment from the landside toe.

View of the material, garbage and equipment along the landside toe

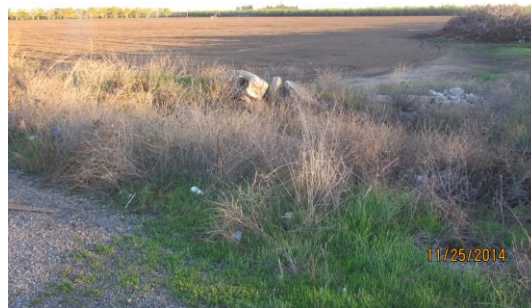
Photo 1 of 1 : SP_2015_ST0020_214_1_20150310_00001.jpg

LM Start	2.95	Rating **	M	Issue No.	1
LM End	2.95	Issue Type +	En	Location *	LS
Category	Earthen Levee			GPS Latitude/Longitude	
				Start	End
Item	Encroachments			39.170598 °	39.170598 °
				-121.671807 °	-121.671807 °
DWR ID	DWR_ST0020_02_f_2014_1				
Action/Comments					
Material					
Inspector Comments: Remove the concrete from the landside toe.

View of the concrete along the landside toe.
